Contract #: 04-0120F4Cty: SF/ALA Rte: 80 PM: 13.2/13.9File #: 69.28**WELDING INSPECTION REPORT****Resident Engineer:**Siegenthaler, Peter**Address:** 333 Burma Road**City:** Oakland, CA 94607**Report No:** WIR-016569**Date Inspected:** 03-Sep-2010**Project Name:** SAS Superstructure**OSM Arrival Time:** 700**Prime Contractor:** American Bridge/Fluor Enterprises, a JV**OSM Departure Time:** 1900**Contractor:** Zhenhua Port Machinery Company, Ltd (ZPMC), Changxing Island **Location:** Shanghai, China**CWI Name:** Zhu Zhong Hai.**CWI Present:** Yes No**Inspected CWI report:** Yes No N/A**Rod Oven in Use:** Yes No N/A**Electrode to specification:** Yes No N/A**Weld Procedures Followed:** Yes No N/A**Qualified Welders:** Yes No N/A**Verified Joint Fit-up:** Yes No N/A**Approved Drawings:** Yes No N/A**Approved WPS:** Yes No N/A**Delayed / Cancelled:** Yes No N/A**Bridge No:** 34-0006**Component:** OBG components.**Summary of Items Observed:**

OBG Trial Assembly Yard:

WELDING INSPECTION REPORT

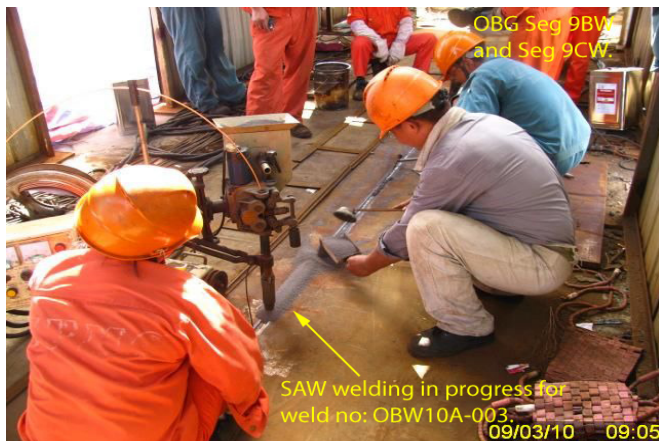
The Submerged Arc Welding (SAW) process on weld joint no: OBW10A-003. The welders are identified as 042195 and 202756 and were observed welding in the 1G position. ZPMC QC was identified as Shi Lei. The welding variables recorded by QC appeared to comply with WPS: B-T-223(2)1T-T. See attached photo for further details.
